PHP - Technical Bulletin

Bulletin Number: TB-140201

Subject: PHP-23A ECU Updates

Scope: PHP-23A Heaters Manufactured Prior to 2013

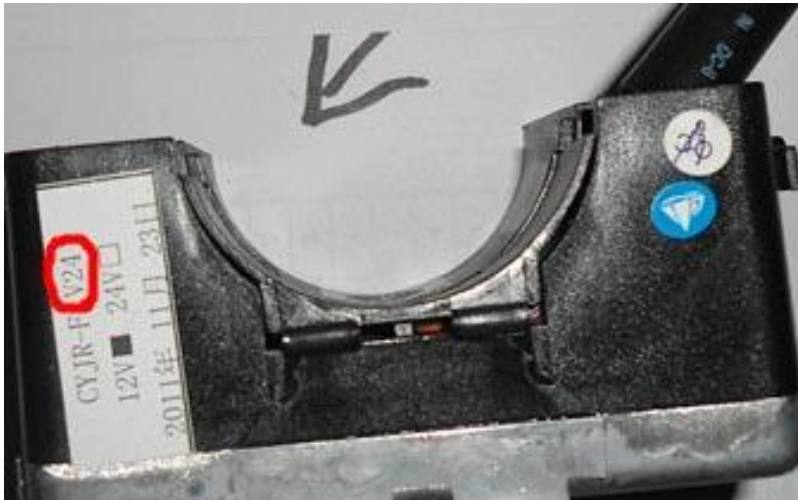
All current glow pins and ECUs in our inventory are of the improved version. The version of ECUs can be identified by the Version Number Stamped on them (Refer to image below). The improved versions are marked with V26 or higher.

This problem does not affect all heaters and heaters should only be modified if they fail prematurely. When detecting a glow pin failure, check the version of ECU. If the Version is V25 or less, the ECU should be replaced along with the glow pin. ECUs do not need to be replaced if they are version V26 or higher.
