Bulletin Number: TB-211201

Subject: PH53W-A and PH52W-A Seal Kit Part Number: P52W-X801

Issue Date: Dec. 13, 2021 (Revised May 26, 2025)

Scope: 5kW Engine Heaters

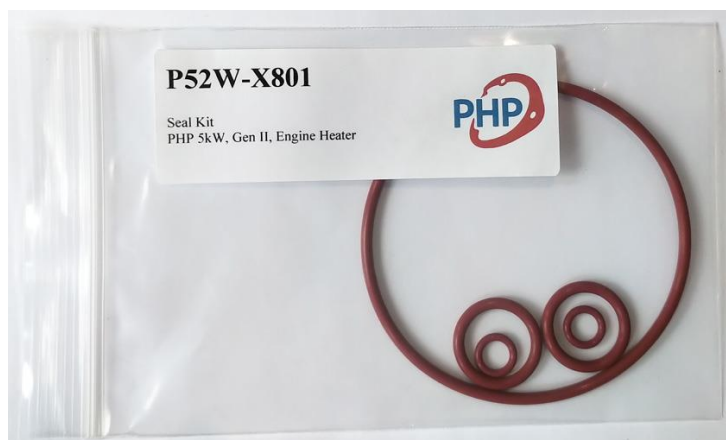
Seal Kit

- 1 of Heat Exchanger “O” Ring
- 2 of Temperature Sensor “O” Rings
- 2 of Inlet /Outlet Port “O” Rings

A seal kit has been developed which includes all required seals for this heater.

These seals are made from Viton which improves their ability to withstand higher temperatures while maintaining their sealing properties.
