# Parking Heater Products – Technical Bulletin

Bulletin Number: TB-251101

Subject: P53W Water Pump Cleaning

Scope: PH53WA, P53W-T601, P53W-T602 Water Pumps

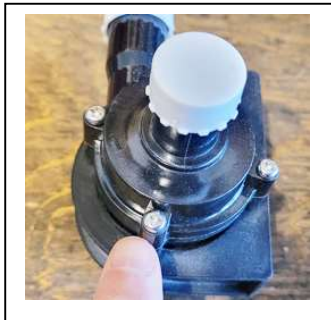
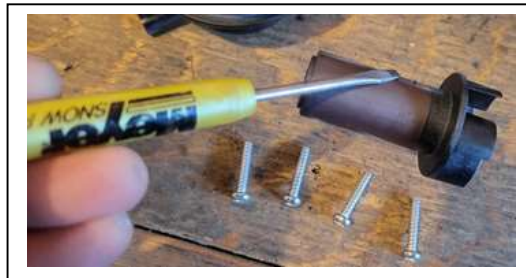
Although this system has tremendous benefits, the one drawback is that the pump can be susceptible to failure if there are steel particles in the coolant system. The impeller that moves the coolant is connected to a magnet. If there are steel particles passing through the pump, they will stick to the water pump. This can cause the pump to seize. This results in a lack of flow which causes the heater to overheat.

To Clean Water Pump: Remove 4 screws, remove pump cover and impeller, clean and reassemble.

Ensure washer and friction plate remain intact.
